Structural Tests of Mechanical Connections For Concrete Panels

L. E. Cattaneo and F. Y. Yokel

Final Report

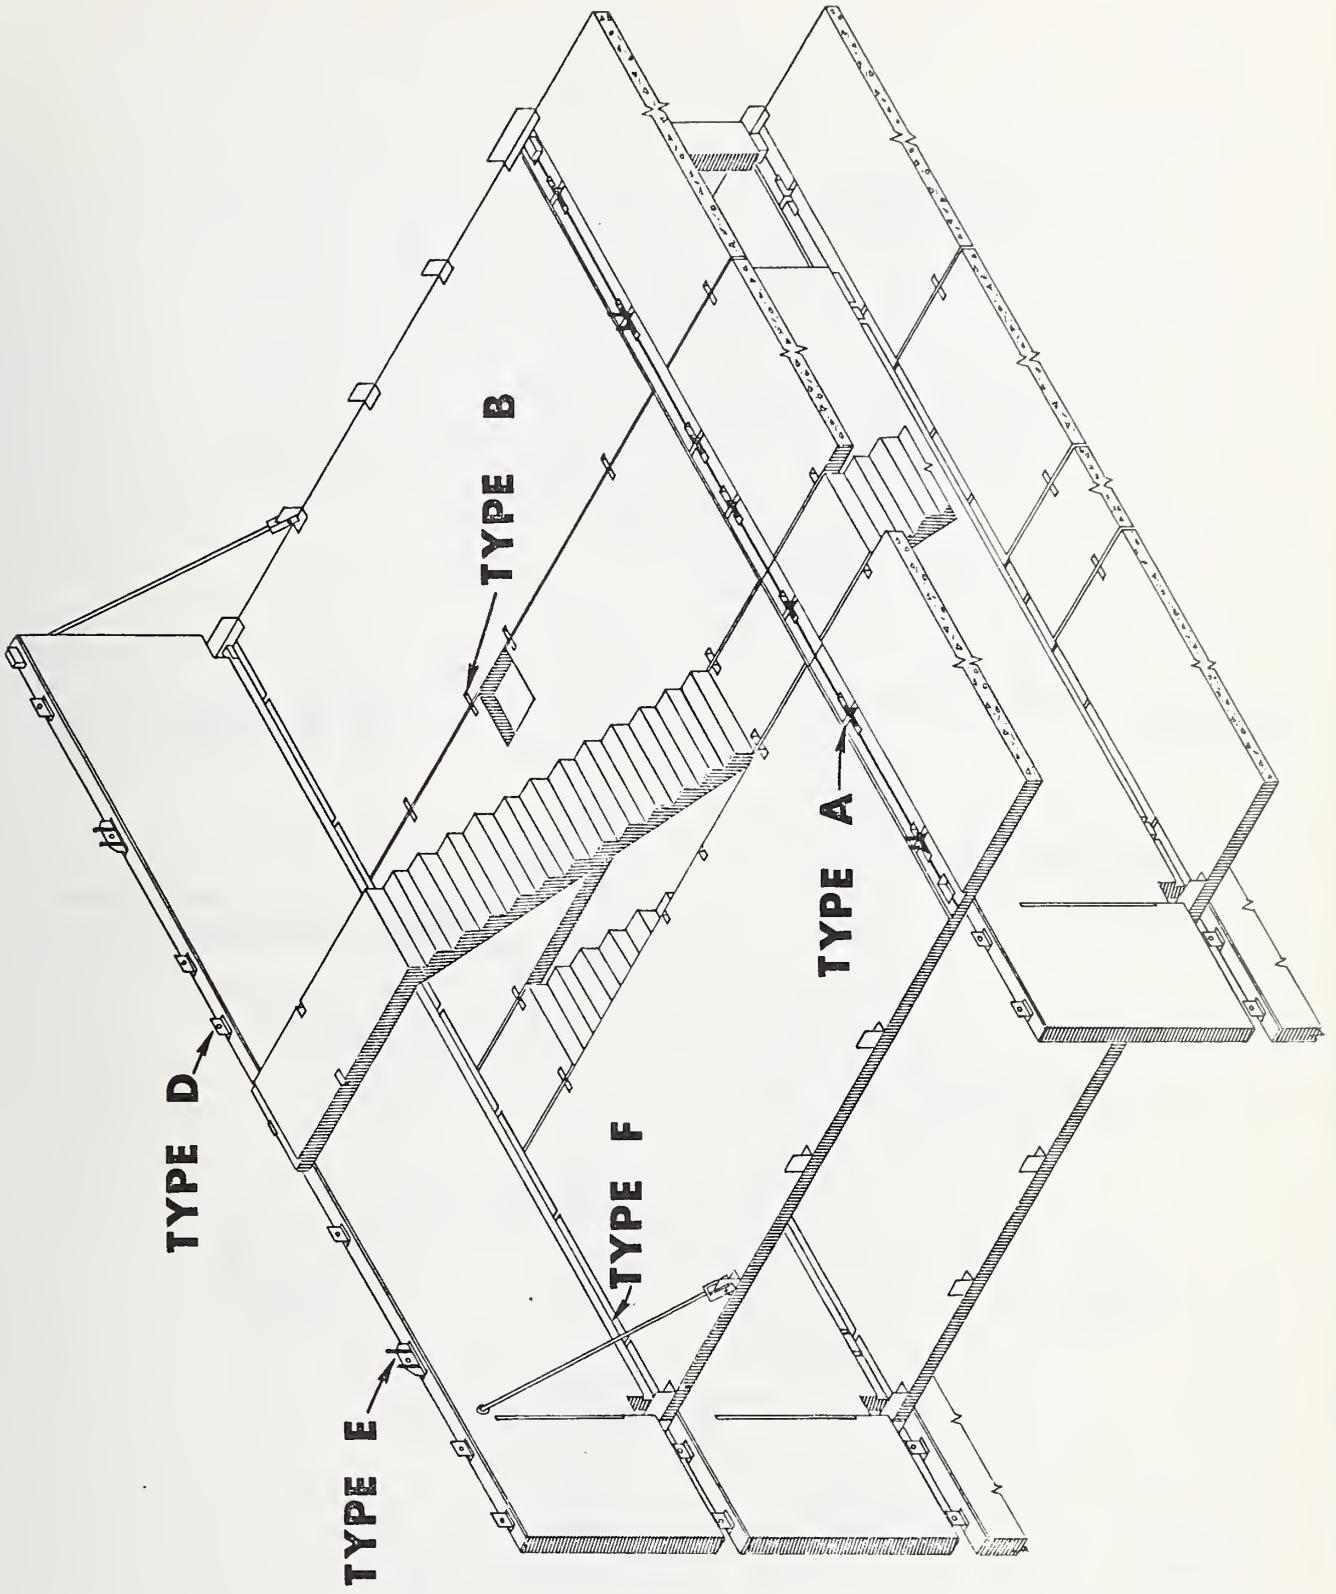
Figure 1.2.1 Connections in panelized housing system.

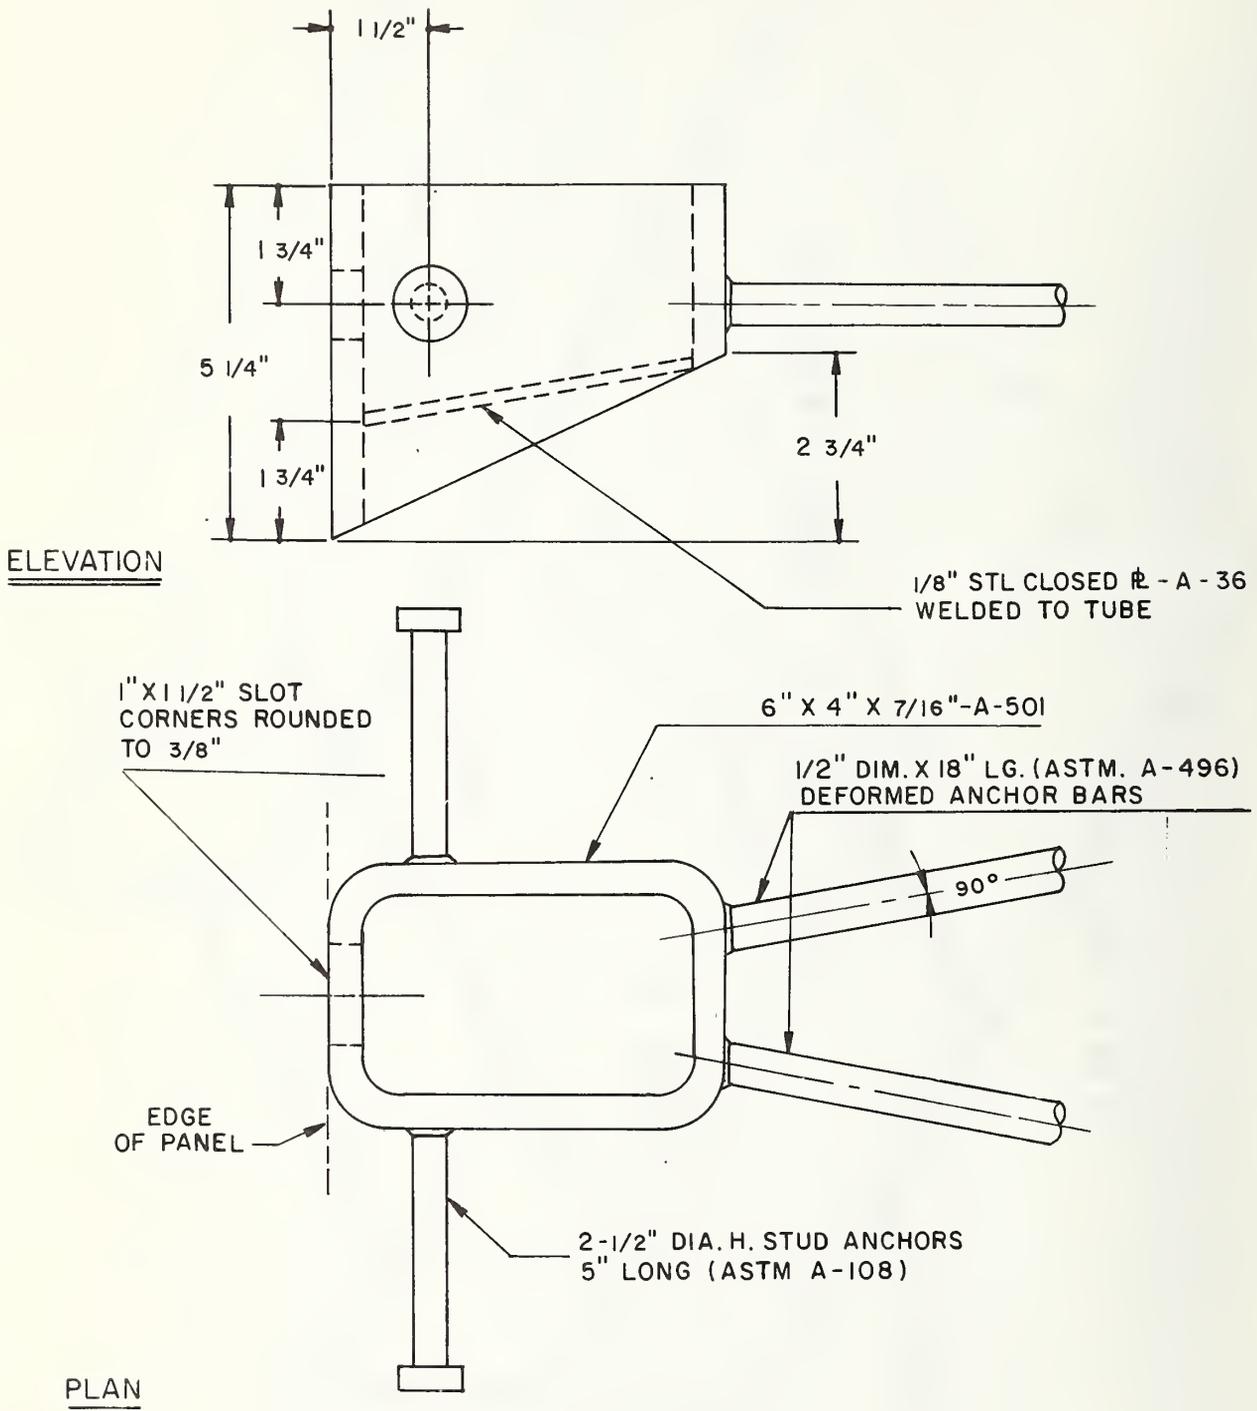
Figure 1.2.2 Type A insert details.

Insert connectors and ancillary hardware used in the tests were supplied by the housing system producer. Details of these parts as used in test specimens which simulated wall and floor panel connections are shown in figures 1.2.2 through 1.2.8. It should be noted that some of the inserts as tested (shown in figs. 1.2.4 through 1.2.6) differ in some respects from the corresponding photographs (1.2.11 through 1.2.13) of the inserts as received. These modifications were made so that the insert connectors would conform to the design changes in effect at the time of testing. Those affected were:

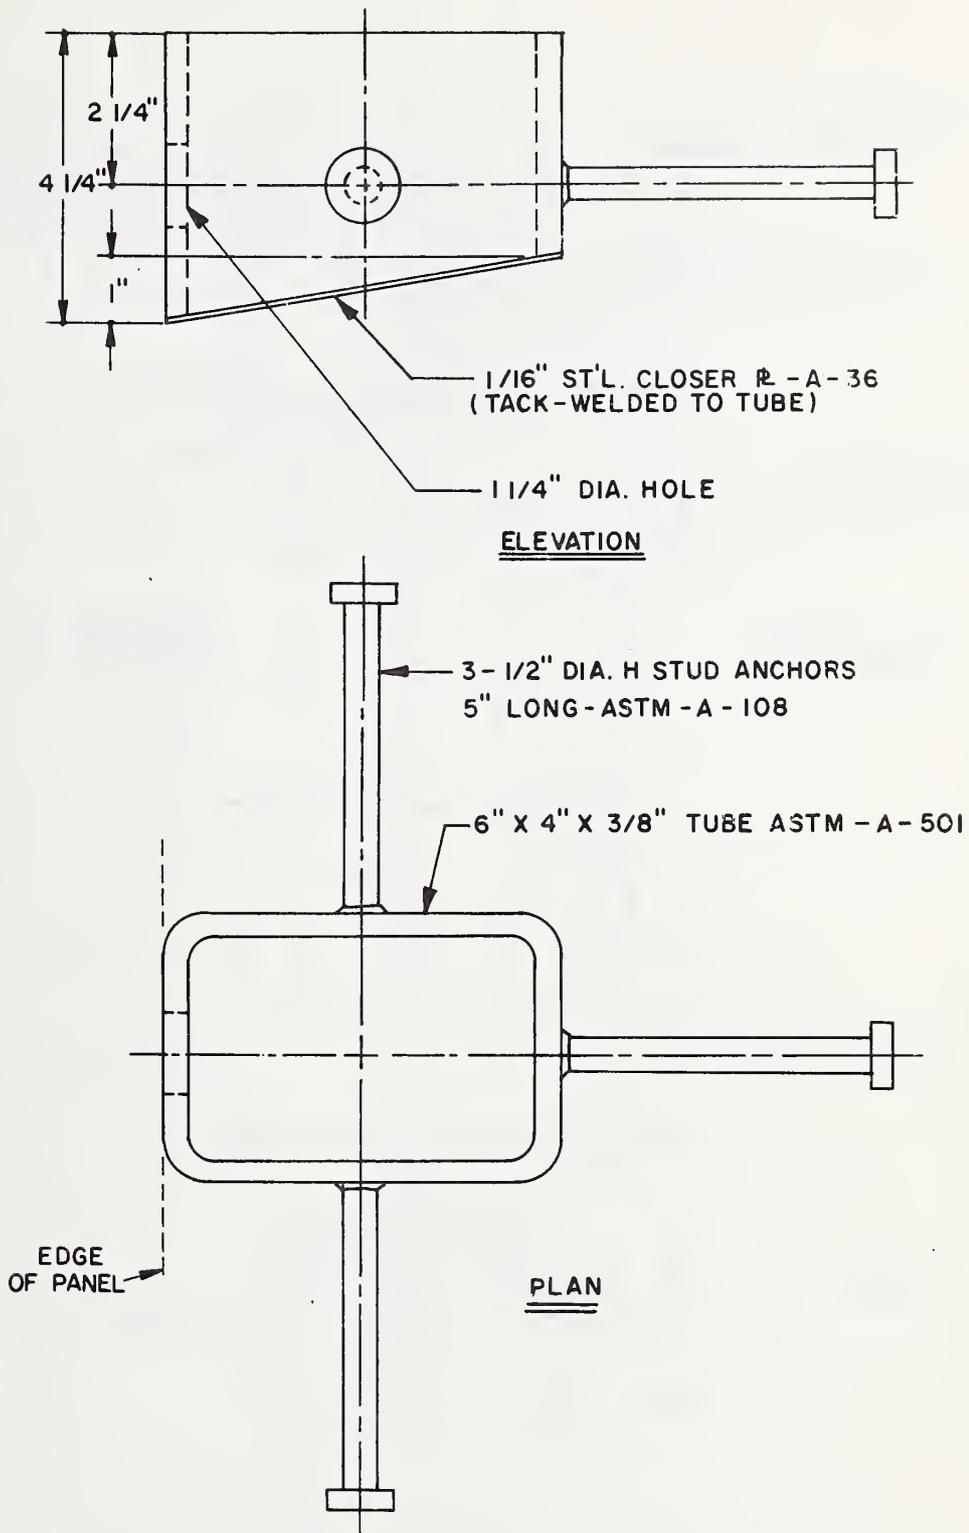
Figure 1.2.3 Type B insert details.

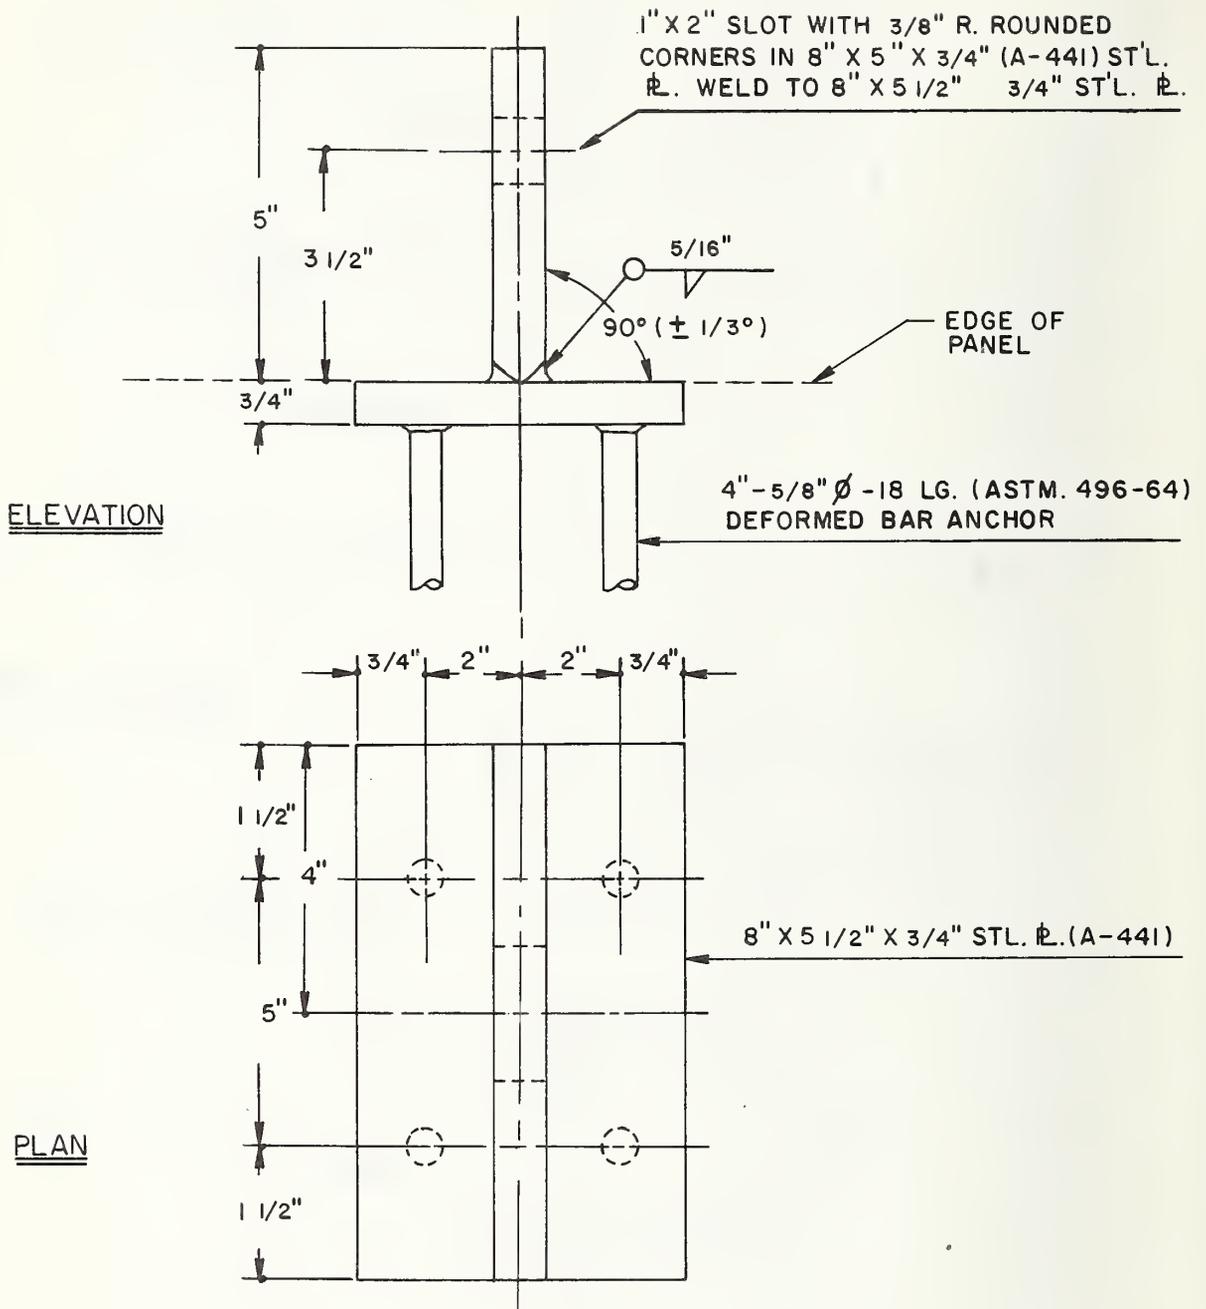
Figure 1.2.4 Type D insert details.

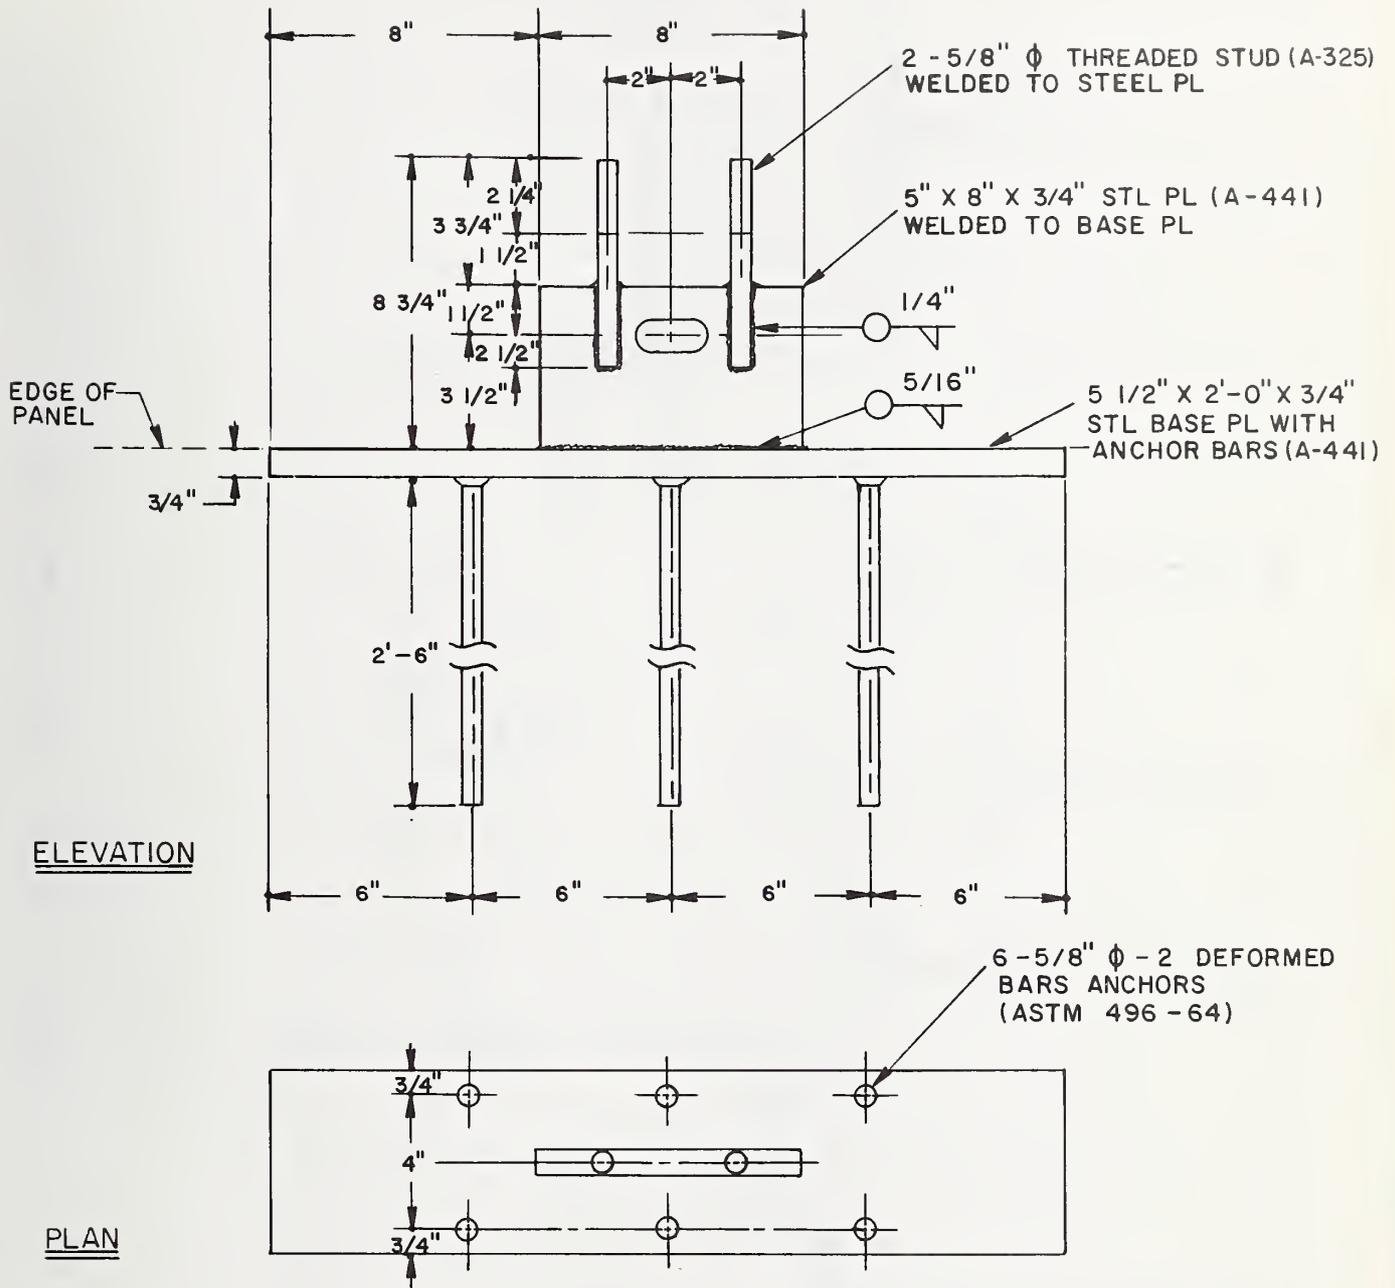
Figure 1.2.5 Type E insert details.

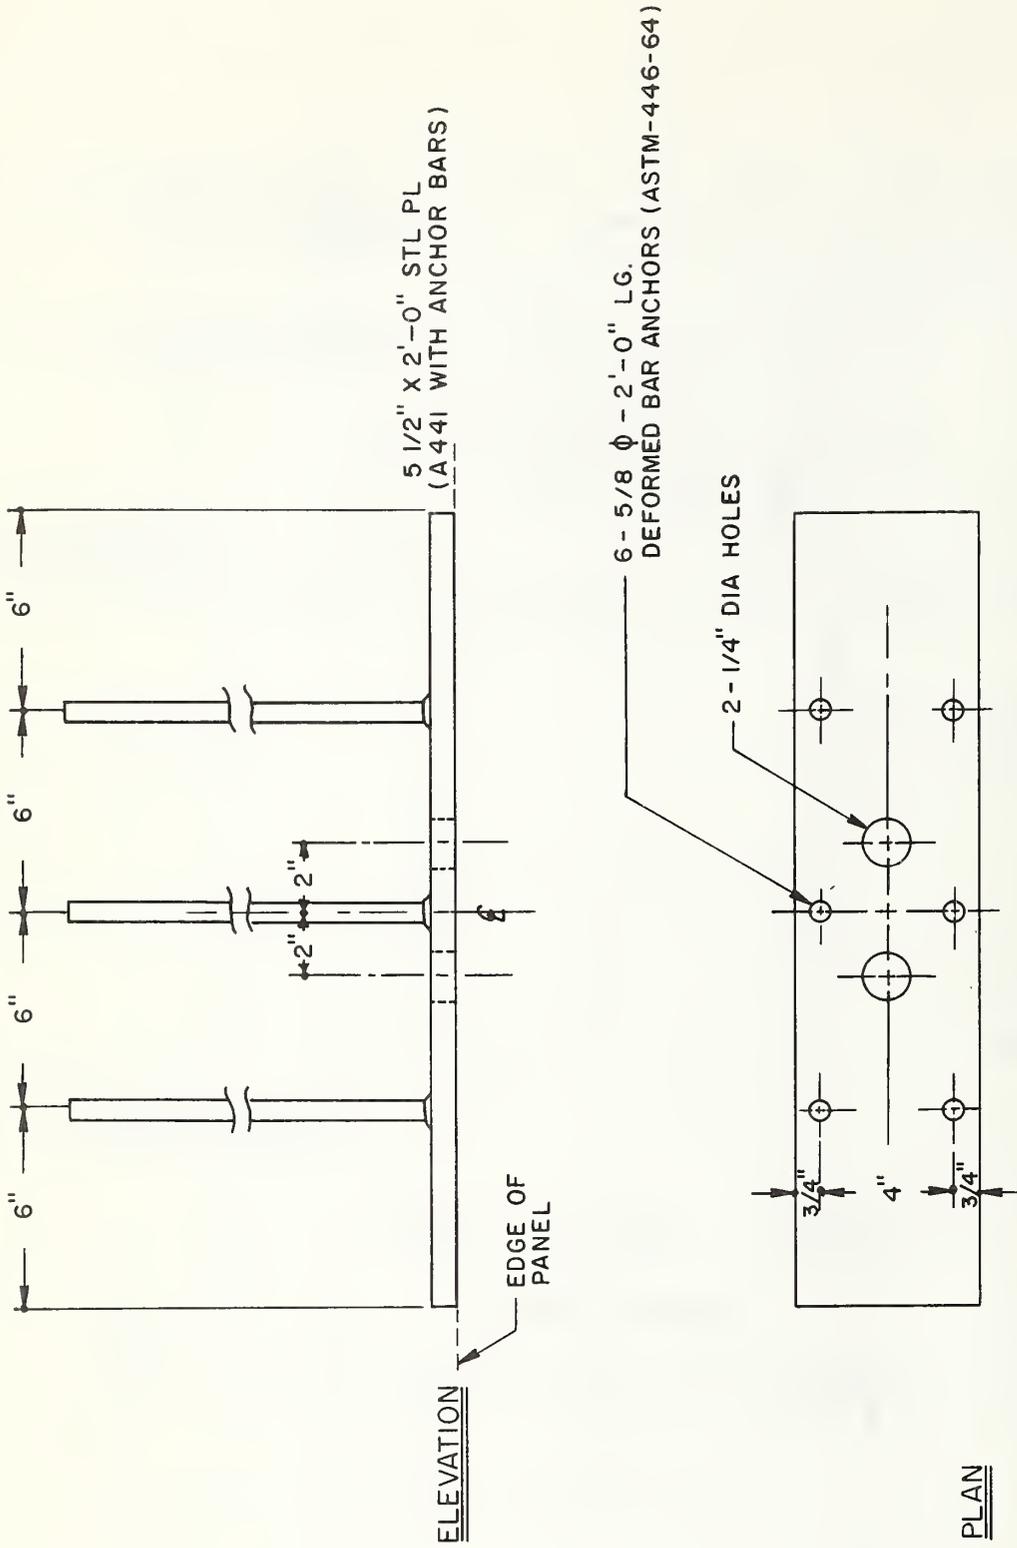
Figure 1.2.6 Type F insert details.

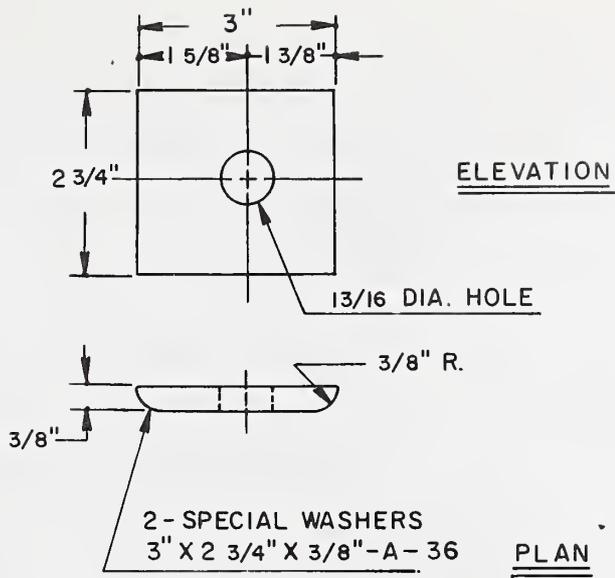
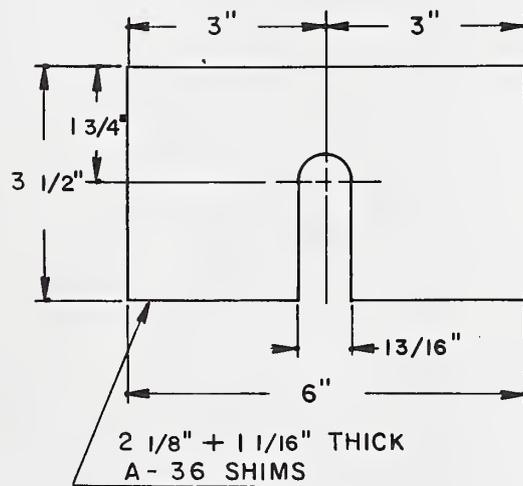
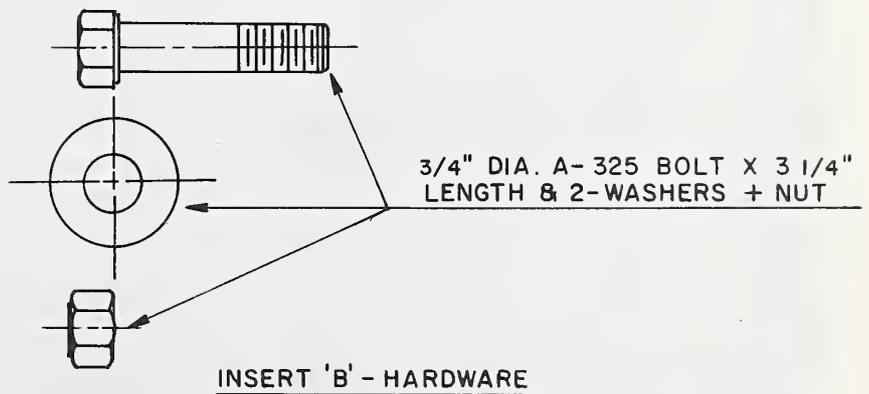
Figure 1.2.7 Hardware for Type B insert.

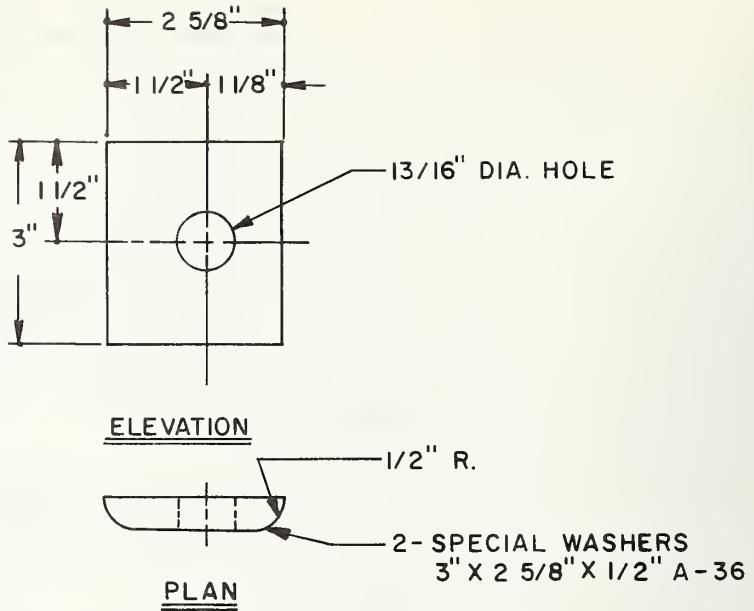
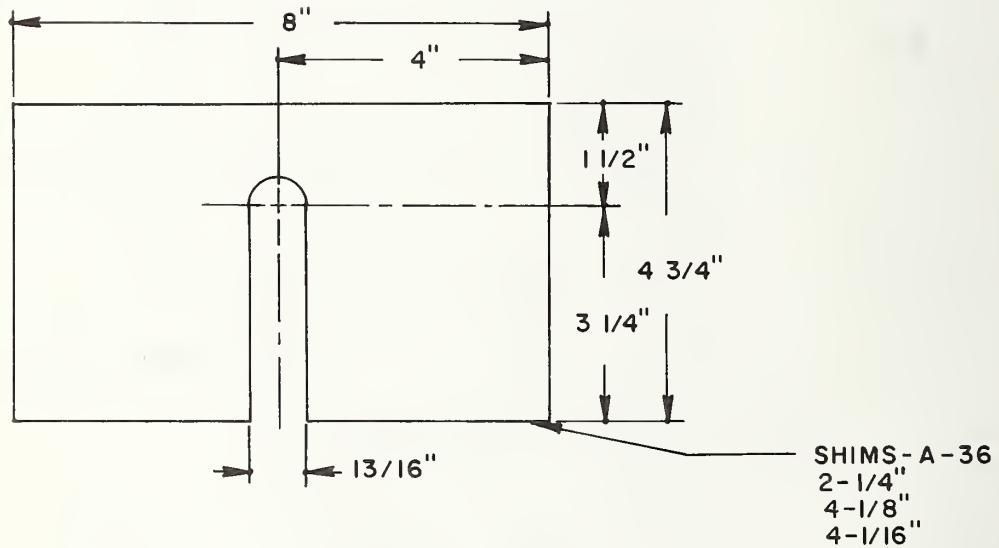
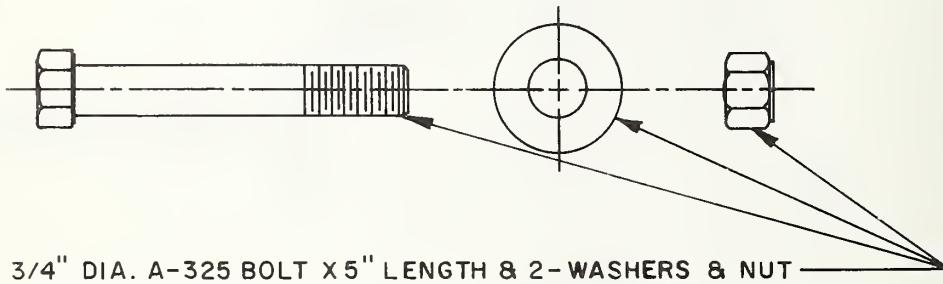
Figure 1.2.8 Hardware for Type A insert.

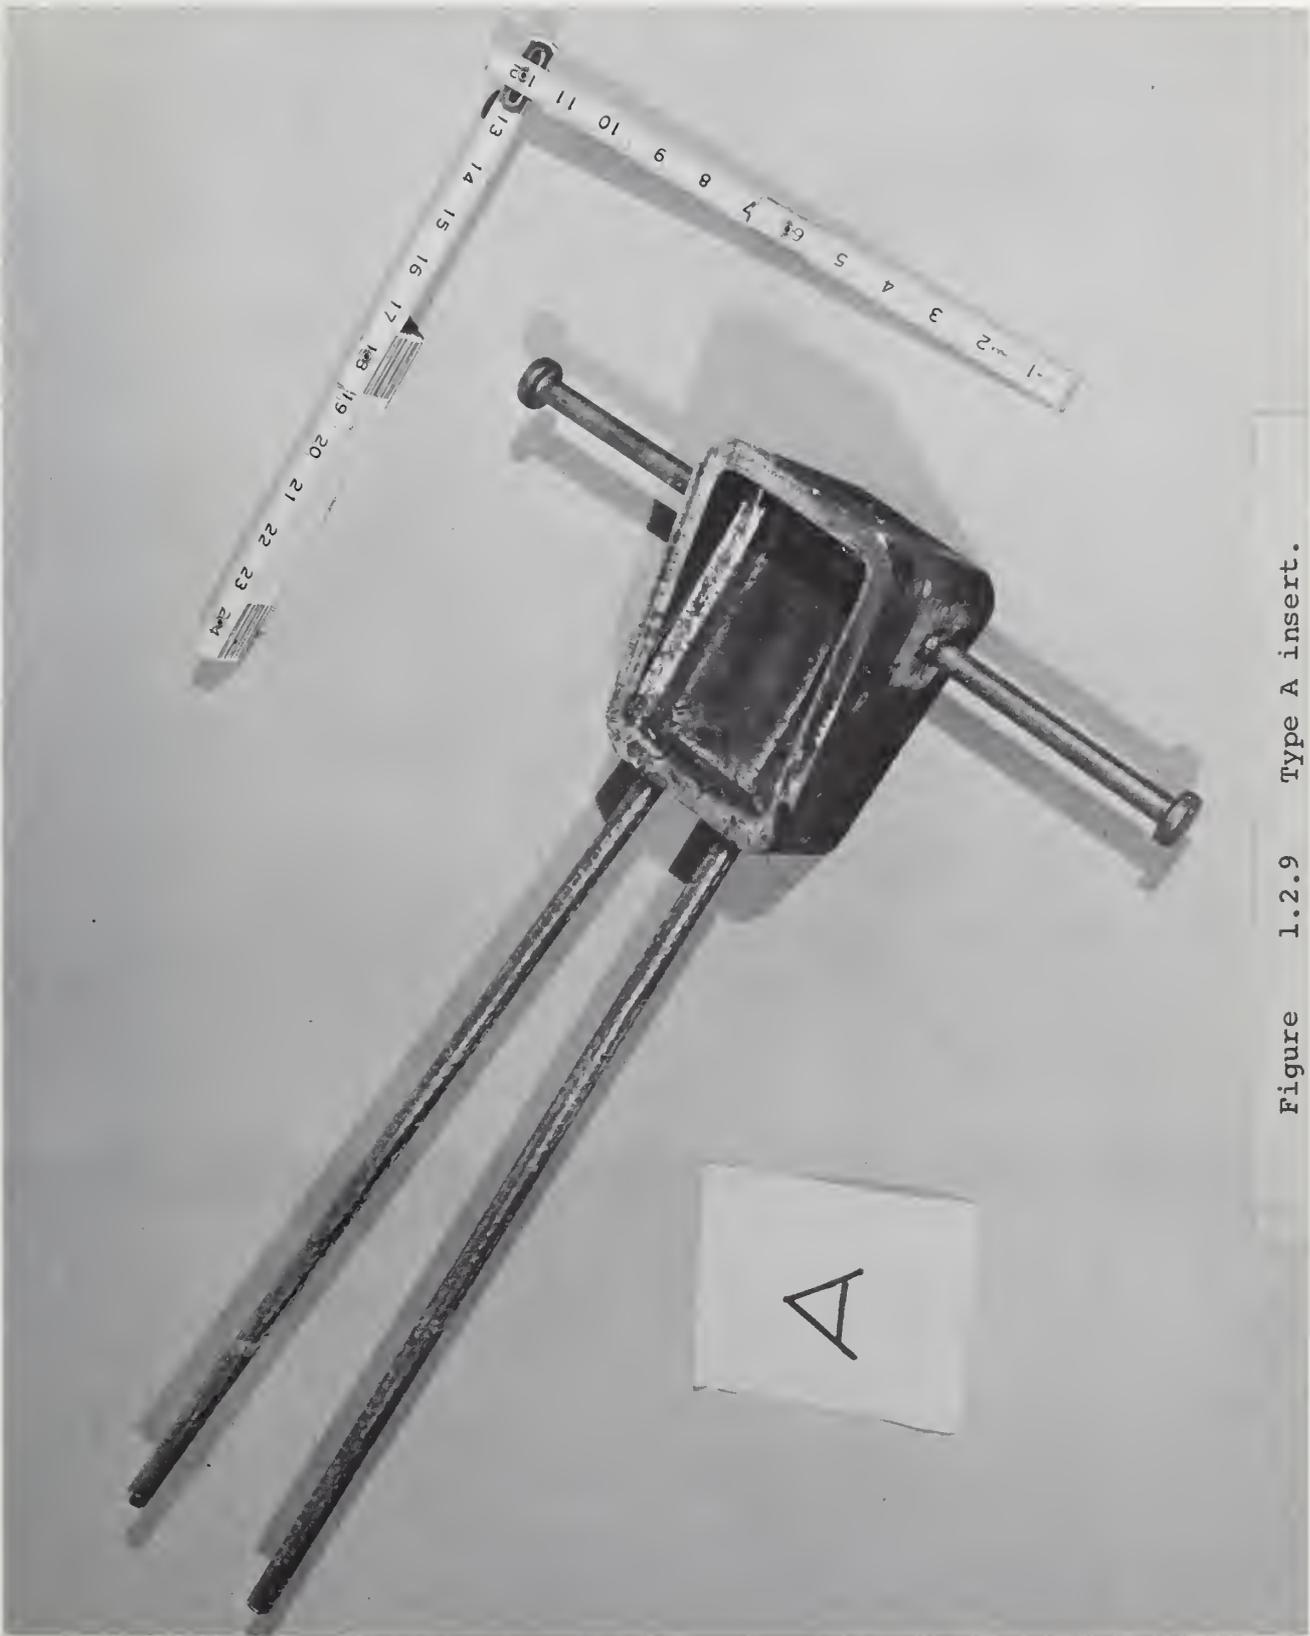
Figure 1.2.9 Type A insert.

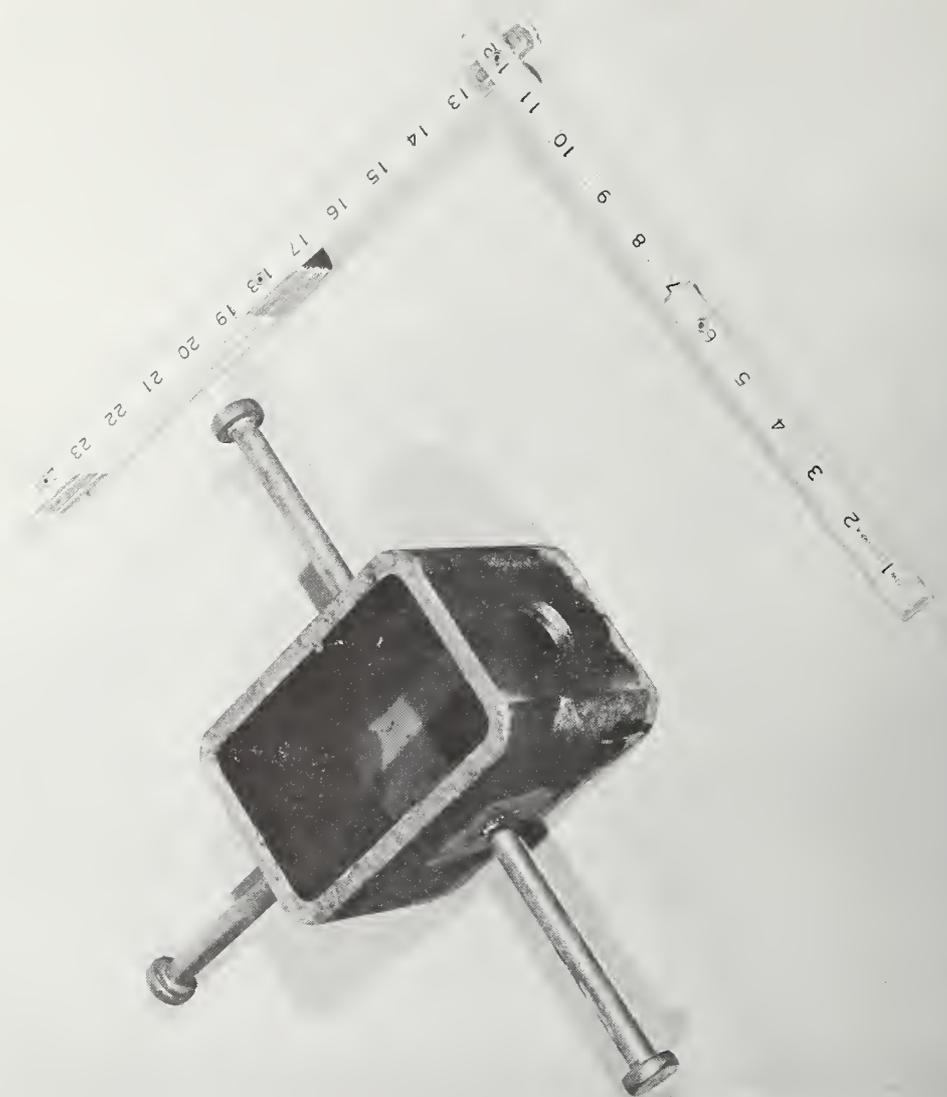
Figure 1.2.10 Type B insert.

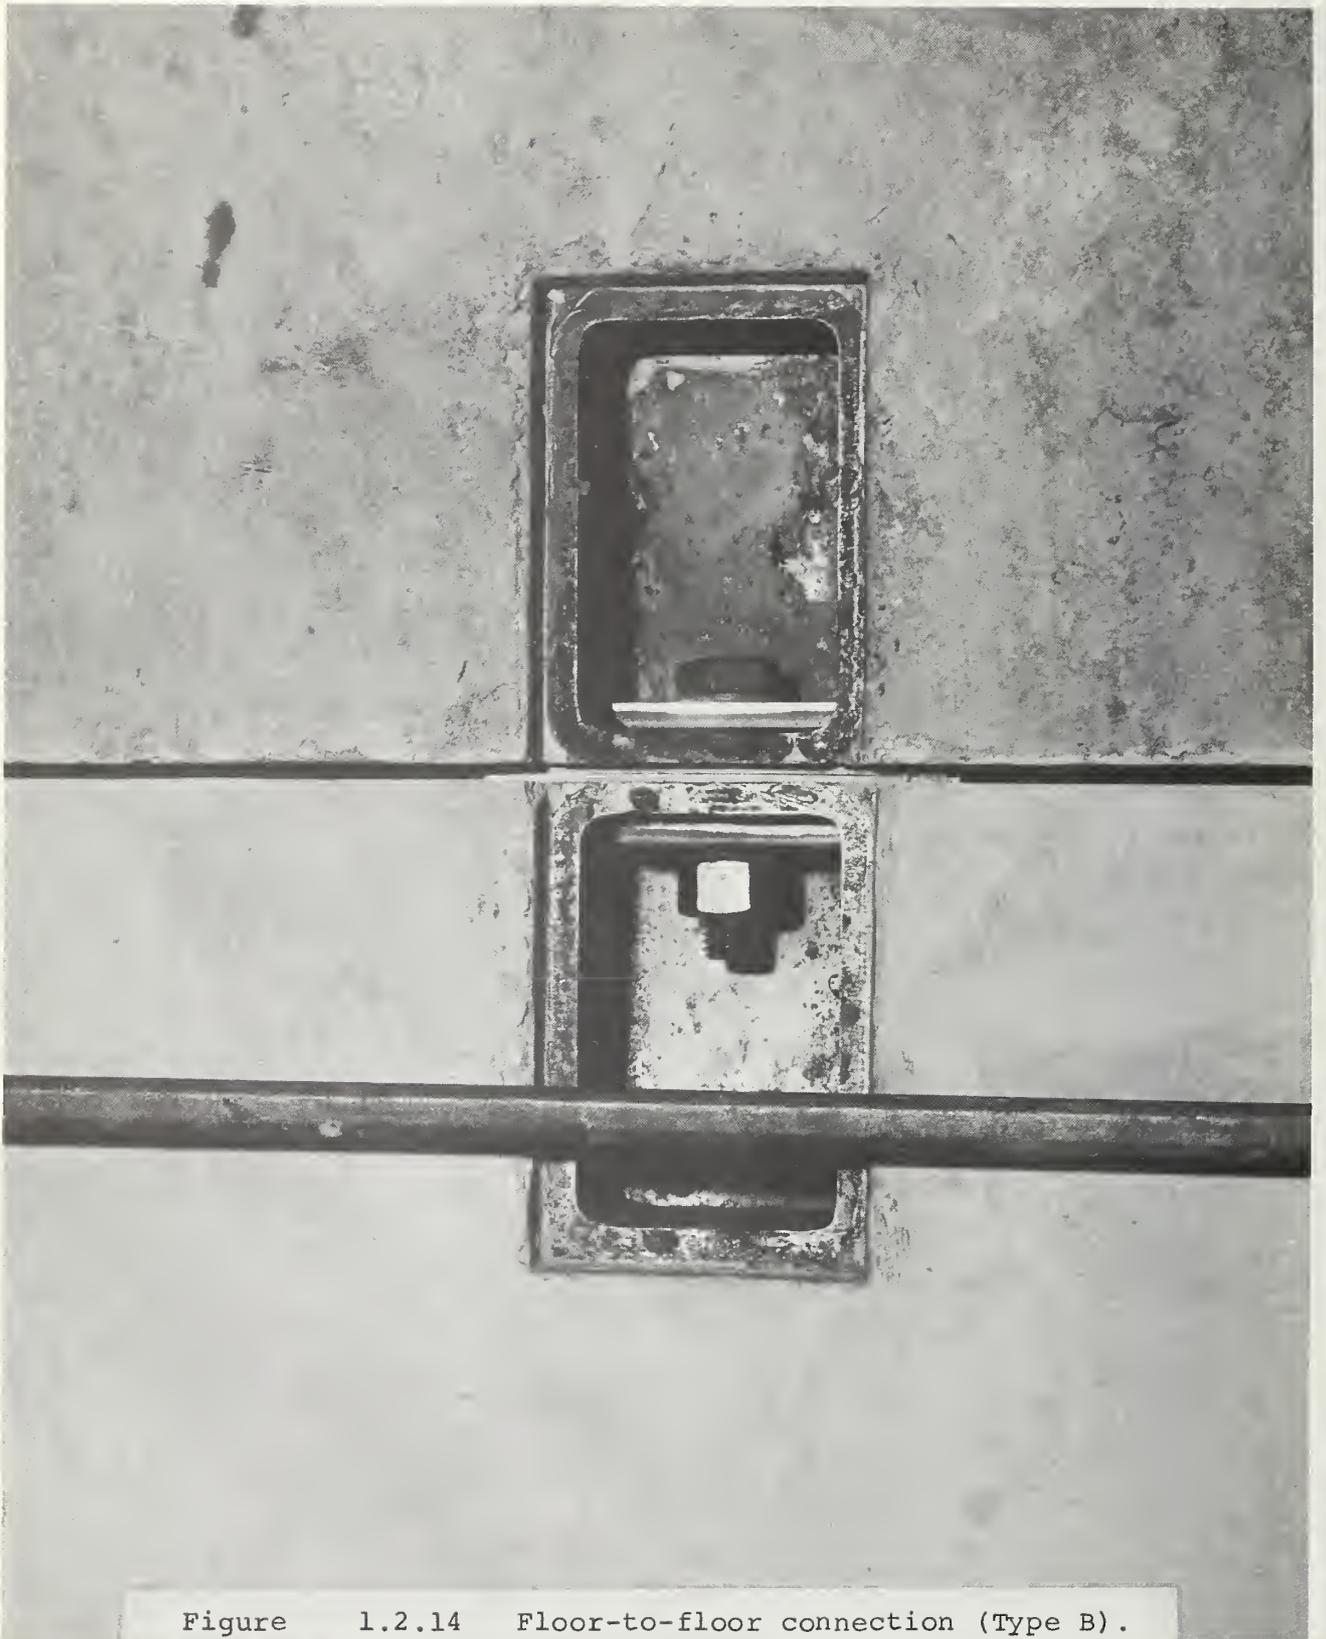
Figure 1.2.14 Floor-to-floor connection (Type B).

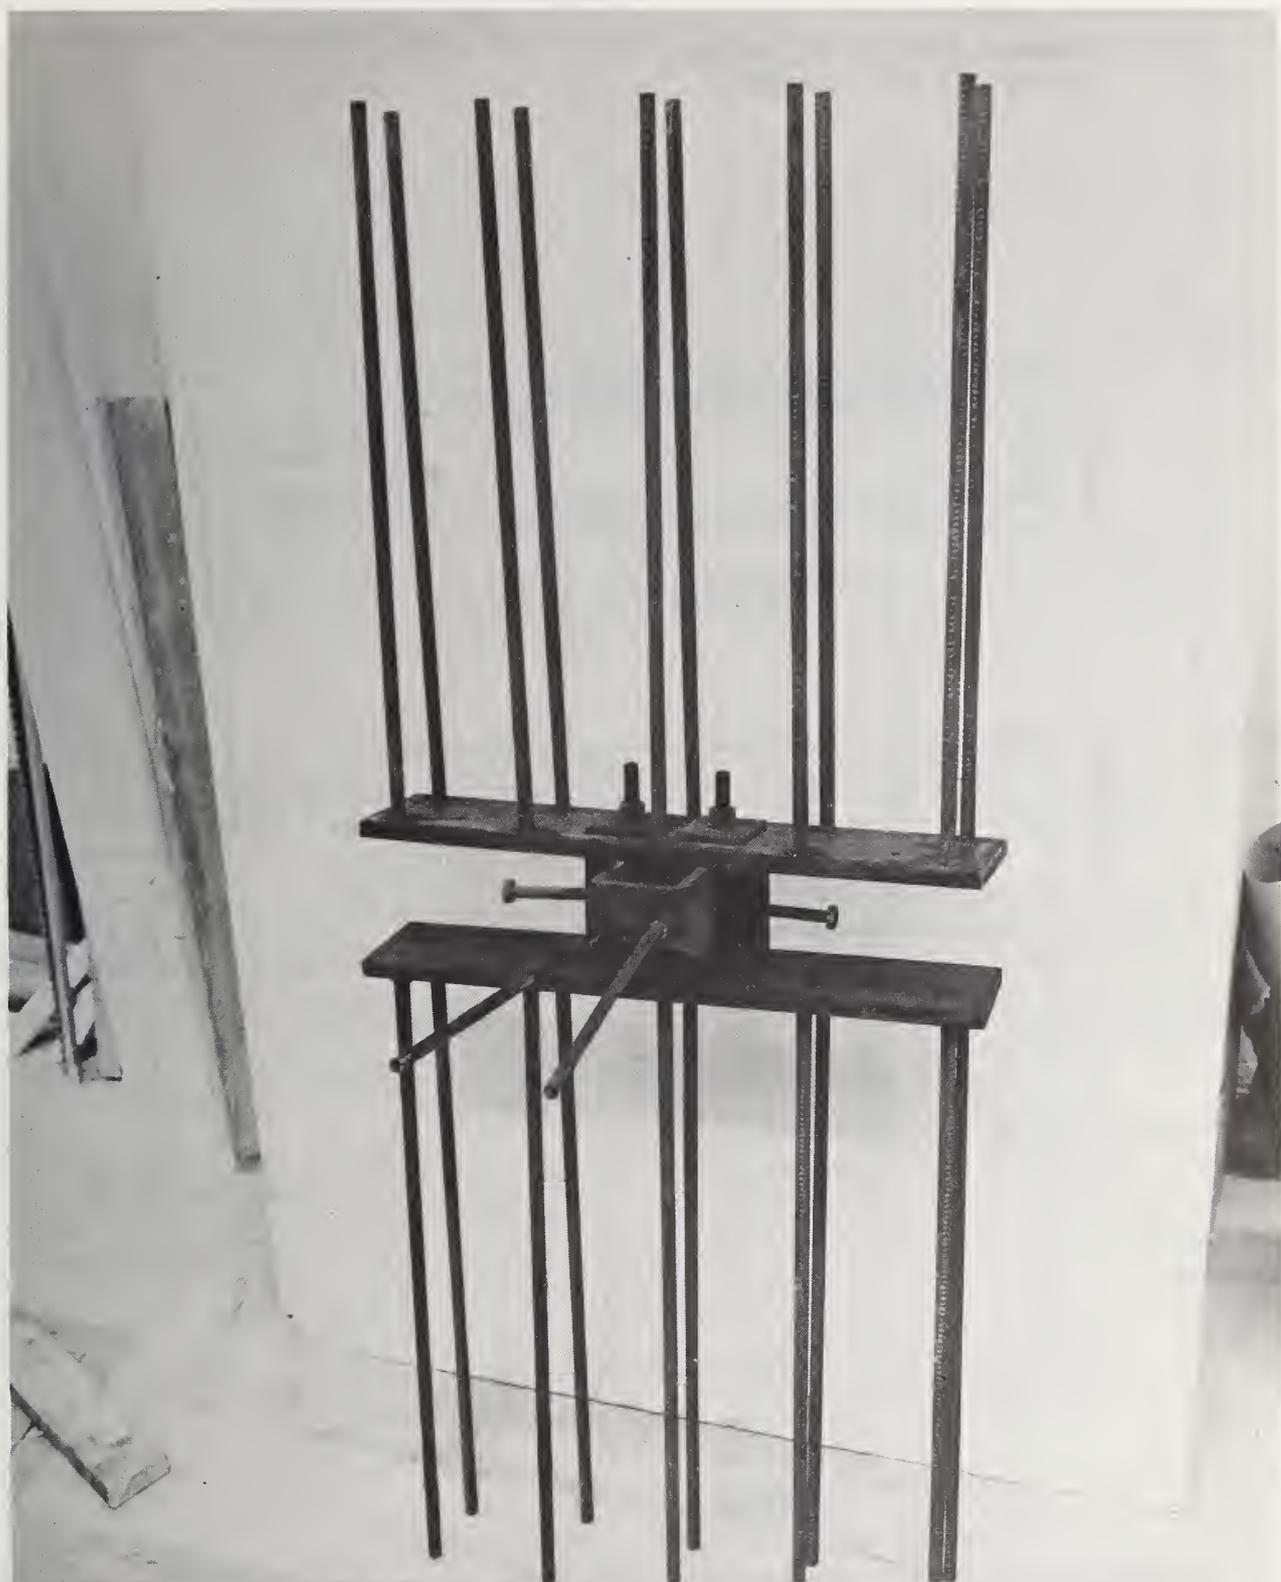
Figure 1.2.15 Floor-to-walls connection (skeletal) (Types A to E to F).

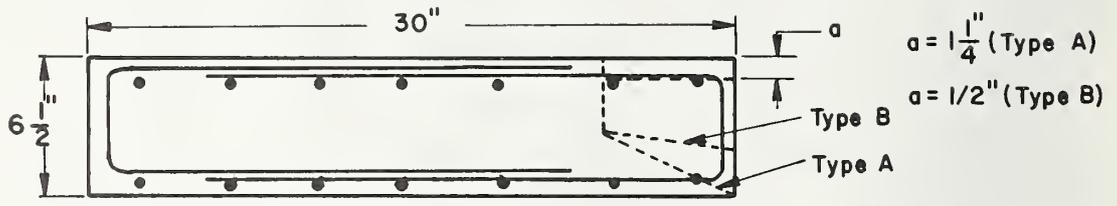
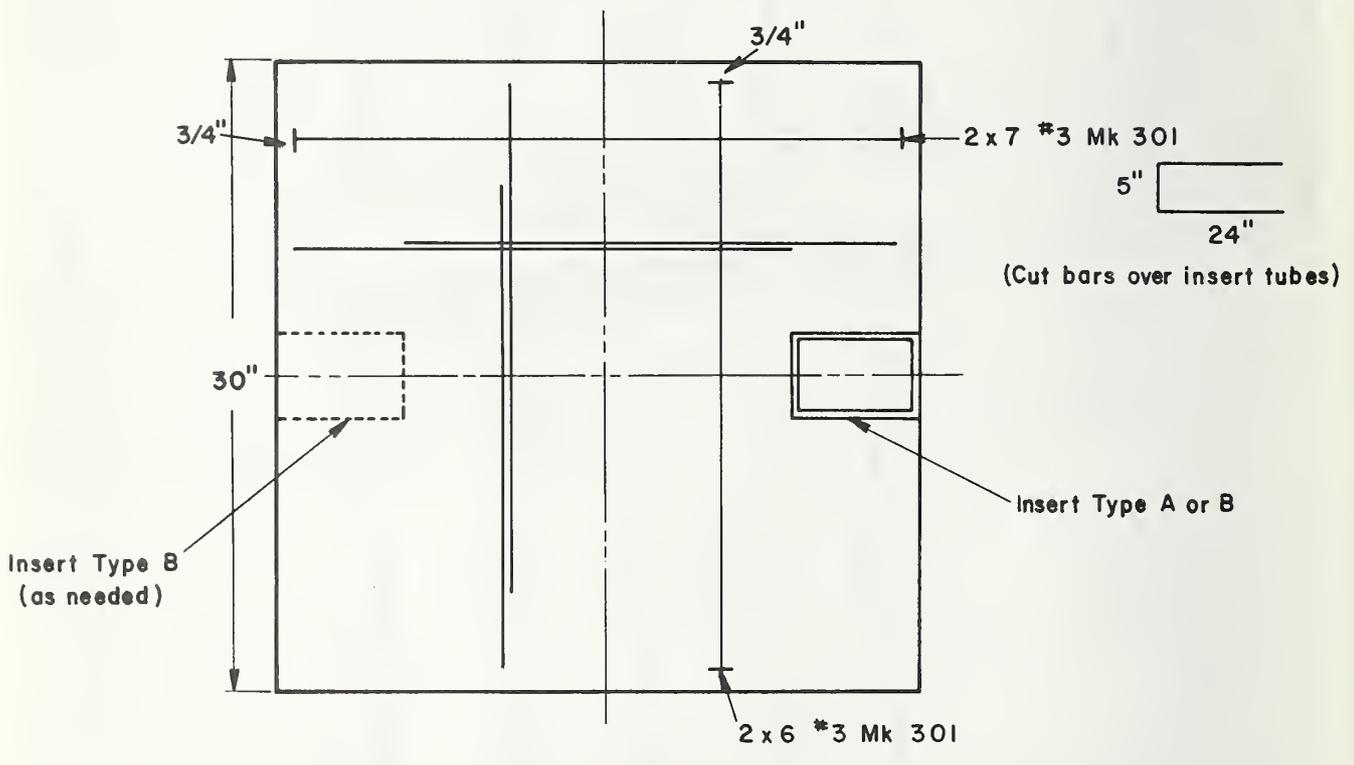
Concrete: 5000 psi @ 28 days
 Re. Steel: A-615-Grade 60

Figure 2.2.1 Original design of floor test specimens (Types A,B).

The hairpin bars in the Test 2 specimen, shown in figure 2.2.1, provided more restraint to the wing studs than the reinforcing bars used in the Test 1 specimen, shown in figure 2.2.4. The failure mode of these specimens (figs. 4.1.1 and 4.1.4) illustrates the important role of the wing studs and the potential effect of their confinement, since in both cases the concrete covering the wing studs failed. In figure 4.1.4 the specimen was "pulled away" after rupture of the tail anchors to better examine their condition. It can be seen in figure 1.2.2 that the concrete cover of these studs was only 1 1/2 in. Another factor that may have affected capacity was the grouting of the connector tube. However, although the Test 2 specimen was grouted, it is questionable whether this grout did increase its capacity since no deformation had been observed

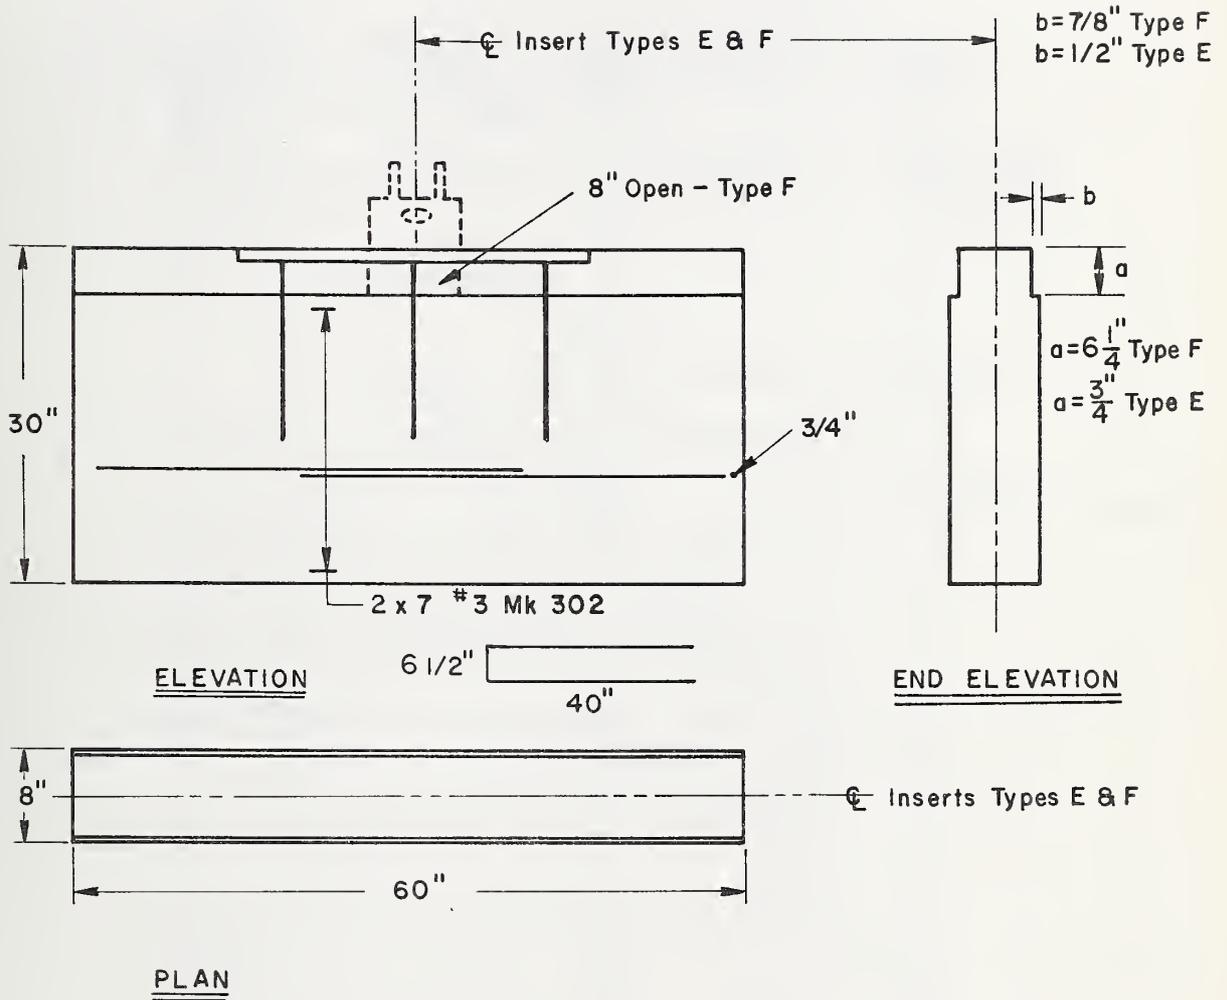
Concrete: 4000 psi @ 28 days
Re. Steel: A-615 - Grade 60

Figure 2.2.2 Original design of wall-end test specimens (Types E, F).
